*Wood Des Focus*. 2013 March ; 23(1): 13–19.

## Techniques for Building an OSHA Compliant Guardrail Structure

**E.A. McKenzie Jr., Ph.D., P.E. and Thomas G. Bobick, Ph.D., P.E., CSP**

Division of Safety Research, National Institute for Occupational Safety and Health Morgantown, WV

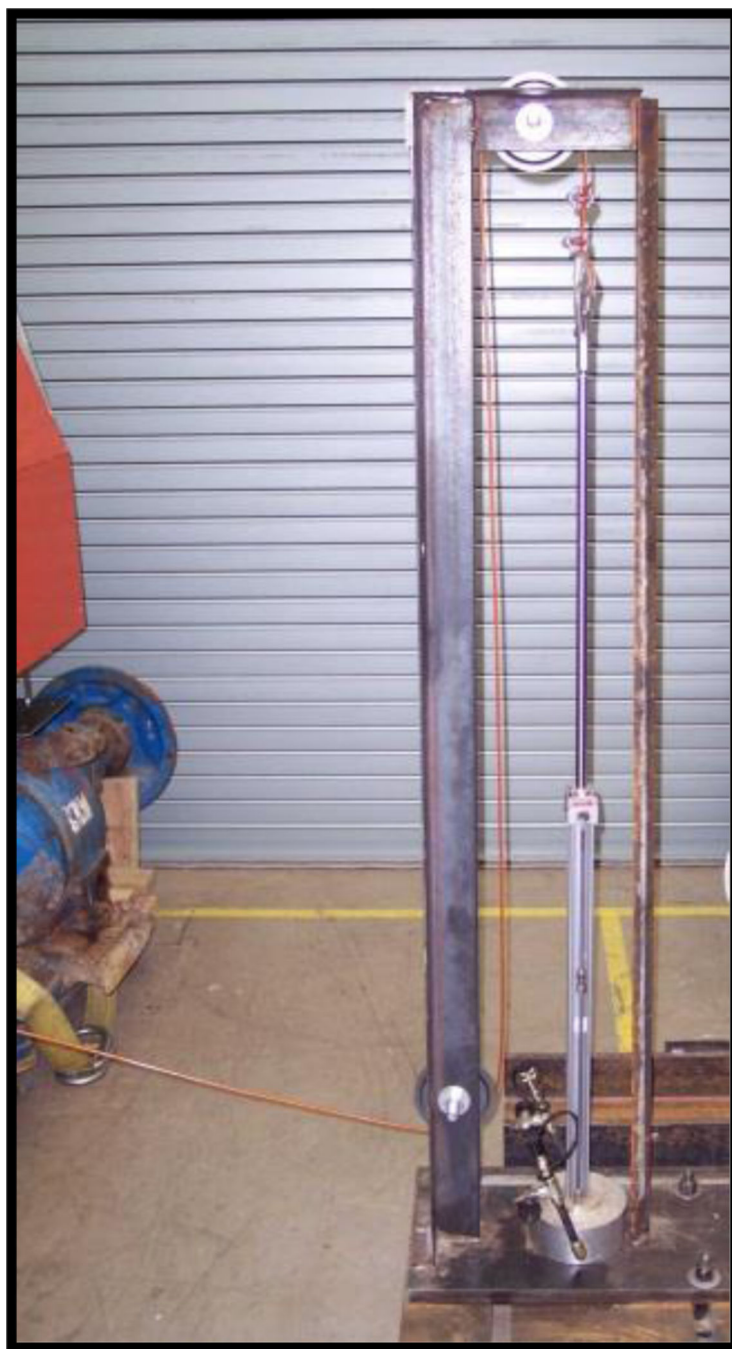
**Figure 2.**  
PTF Testing system

The ultimate strength of each guardrail constructed was evaluated individually by using a NIOSH-developed pull-to-failure (PTF) test. The testing philosophy for this test was to quantitatively evaluate the ultimate strength of each guardrail configuration. The PTF test imposed a sustained force (lasting 2–3 seconds), which far exceeded the OSHA 200-lb falling test duration. A maximum pulling force of 800 lbs was generated using a 2-inch hydraulic cylinder, a battery-operated hydraulic pump, and a cable and pulley system as shown in Figure 2.
